Hawthorne Meadow Feasibility Study

Appendix B —

Report on existing structural
conditions and structural
capacity prepared by Ryan
Hellwig PE

Re: Hawthorne Meadow Farm
235 East Pleasant Street
Amherst, MA

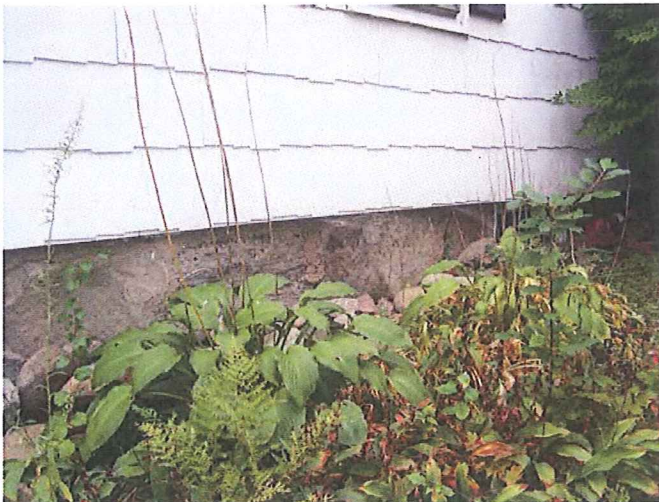
Granite foundation stones and window at right

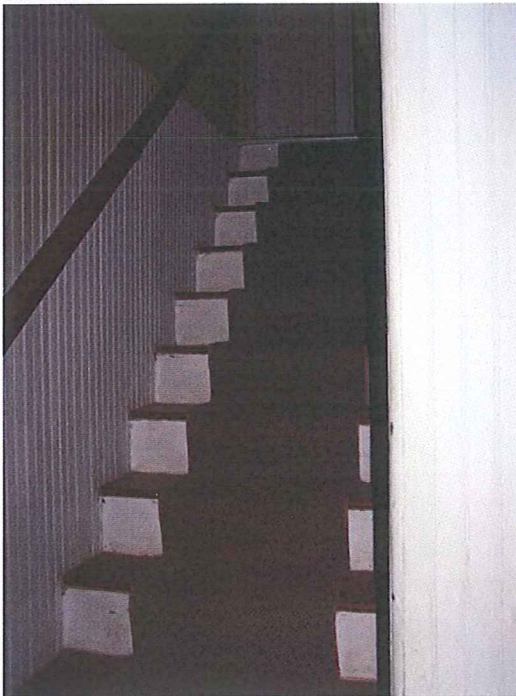
Center staircase inserted in area of original chimney

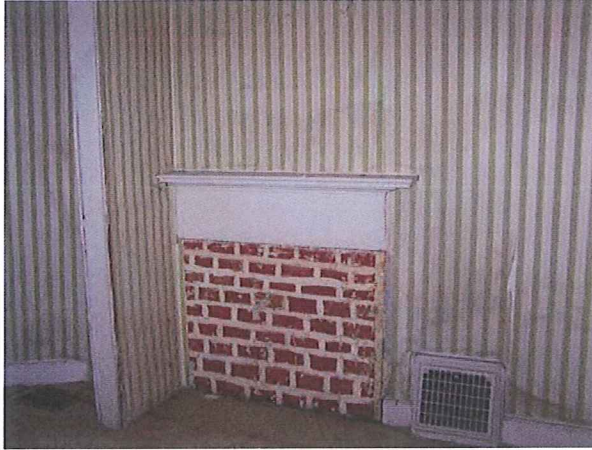
West parlour fireplace remnant blocked with wallboard

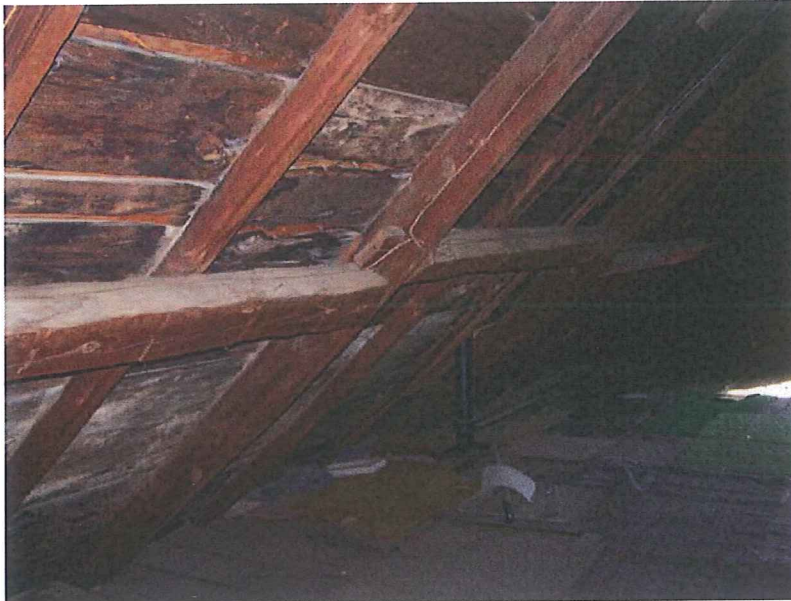
The ends of the purlins have been cut down severely to form tenons that fit into mortises in the principal rafters. This creates a notch effect in the purlins, which weakens the ends. In at least two locations, the grain of the purlins was such that this notching led to a split and shear failure. There is some sag in the roof, more visible from the ground outside.

Purlins staggered and joined to principal rafters

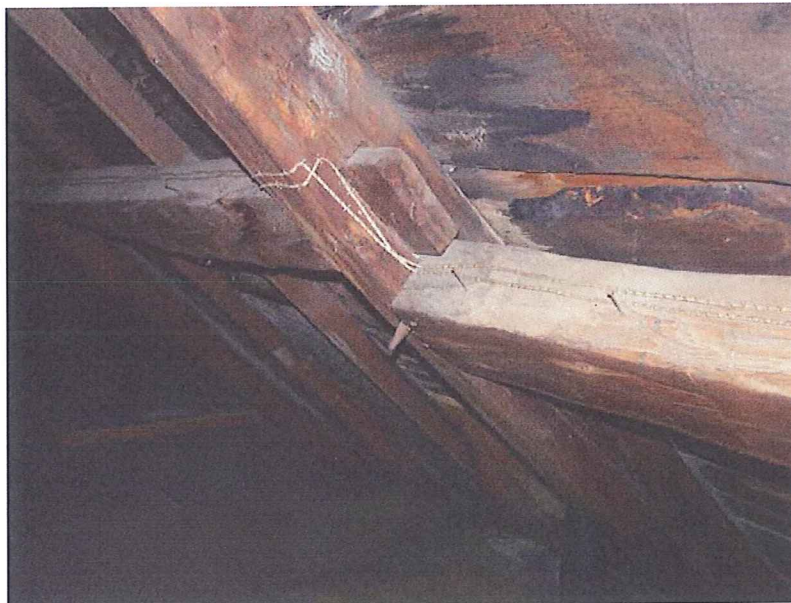
Typical purlin joints with treenail

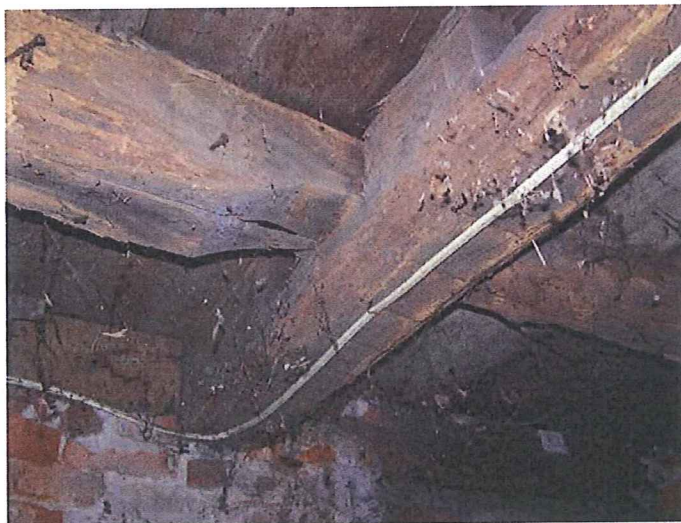
Floor joists and cellar girts are hand hewn, here square rule has been used to fit joint

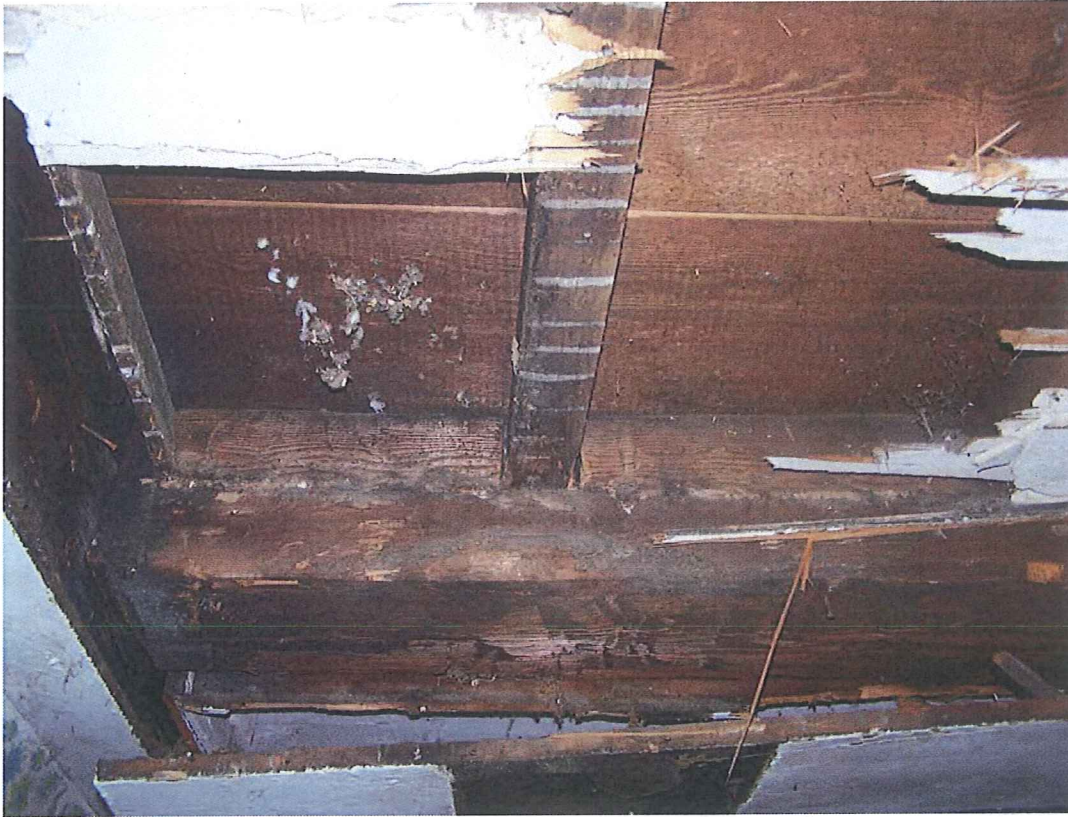
At the first floor level, ceiling lathe and plaster and casing of the summer beam were removed to expose the beam's hewn surface and the surface of the sawmill-cut floor joists of the second floor. Visible in this photograph is the summer beam where it joins the chimney girt on the left and two floor joists that have to the been let in to the summer beam at the center. Close inspection shows that tenoned joints were used for both summer beam and floor joists. This is the strongest joint possible as it does not involve paring down the carrying timber to cut the mortises as do other joint forms. The carrying timber maintains almost all of its original strength. This is an important finding when evaluating the structural strength of the building. The summer beam's faces have not been beveled or otherwise ornamented, so it does not appear that it was originally intended to remain exposed, rather that lathe and plaster were assumed to be the finish surfaces. The lathe is, indeed, hand split and the plaster is an early mixture of animal fur and plaster. In the photograph, the width of the floorboards above is also clear, measuring 14-17".

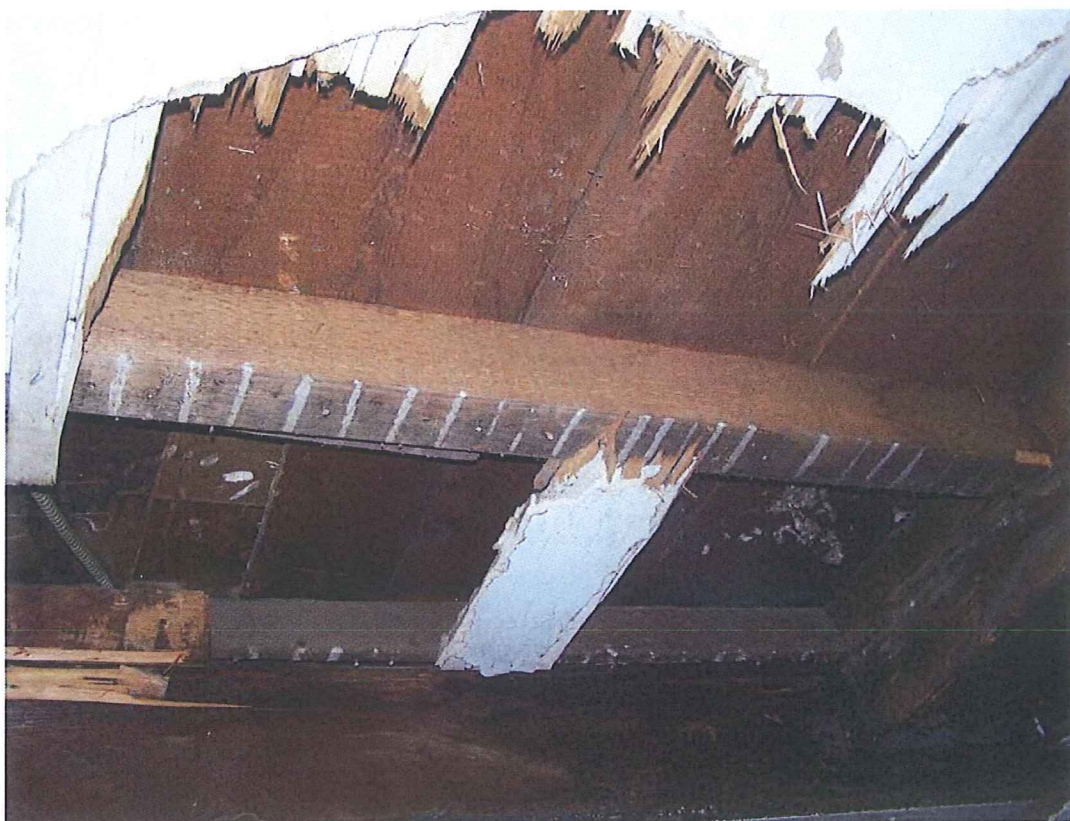
The floor joists's saw marks are those made by a water-powered sawmill equipped with a sash saw. Sash sawmills are thought to have operated as early as 1750 in Leverett at the Joseph Slarrow mill in North Leverett, and were responsible for cutting the timber for framing until about 1850 in the region.

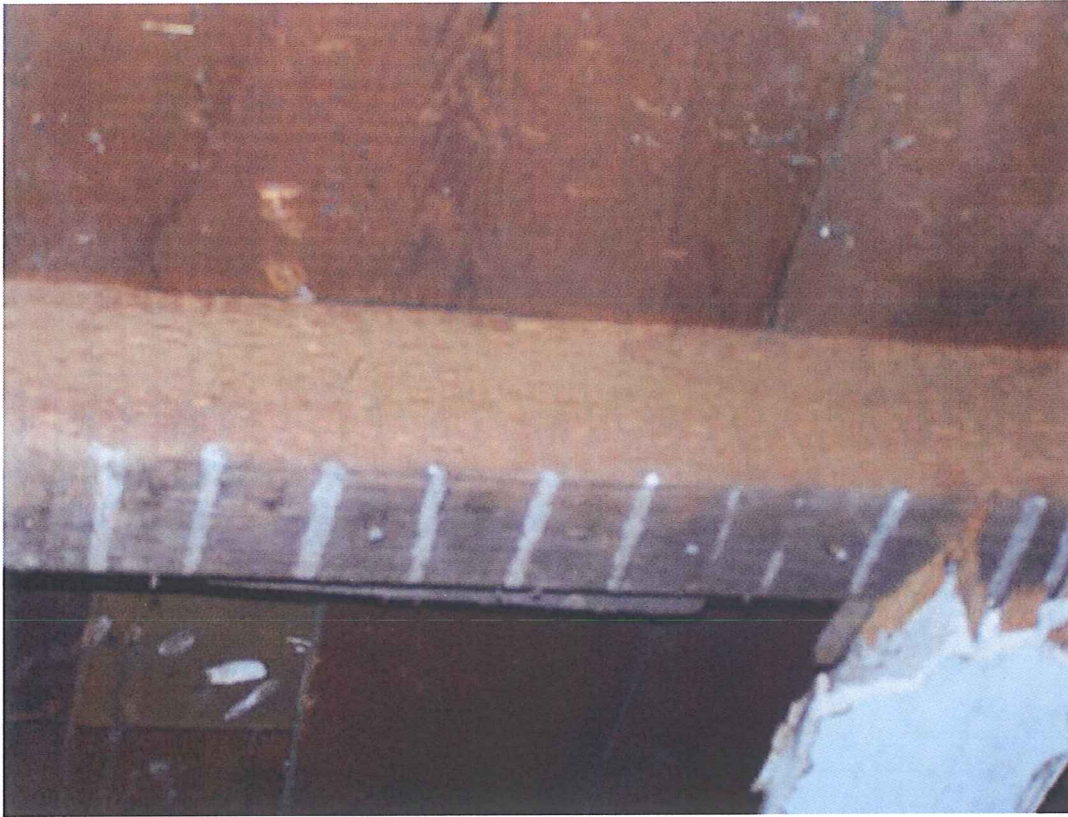
A detail view of the sawmarks shows them to be about $\frac{1}{2}$ to 1" apart and straight, characteristics of the particular type of sash saw.

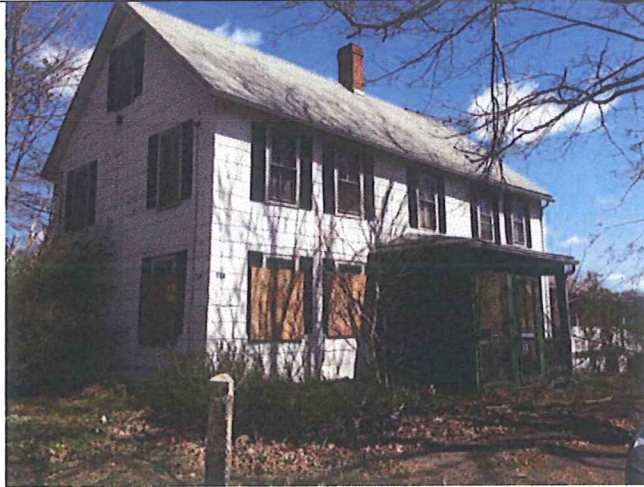
Exterior of the house from East Pleasant Street

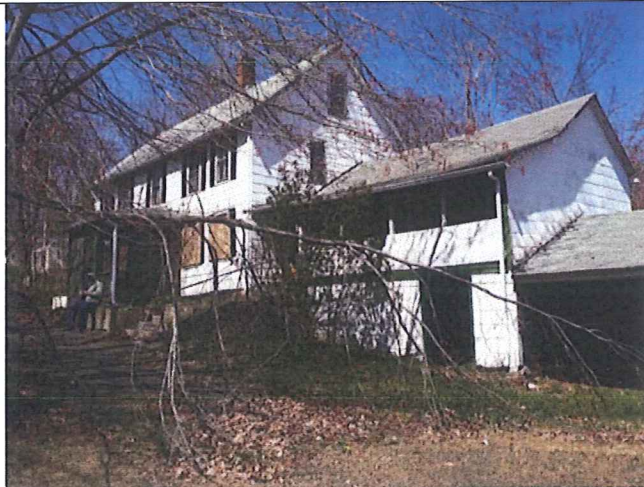
Exterior of house from inside the site looking up toward East Pleasant Street. The "Ell" is in the foreground

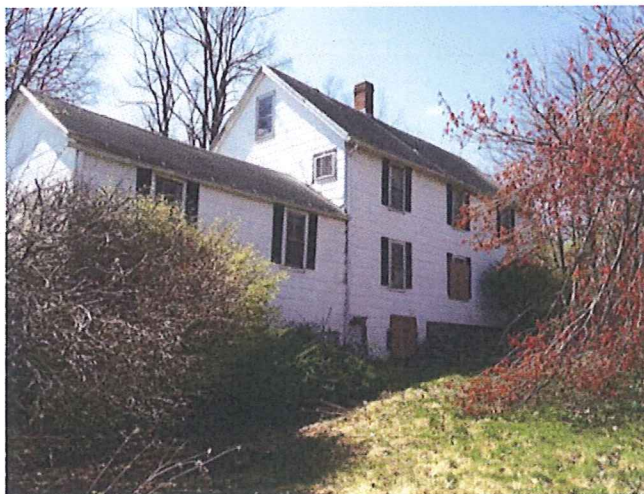
Exterior of the north side of the house and "Ell"

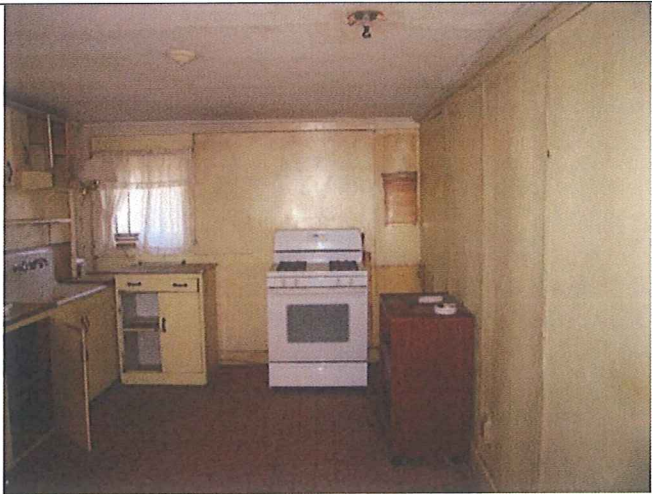
<p>One of the two existing kitchen spaces</p>

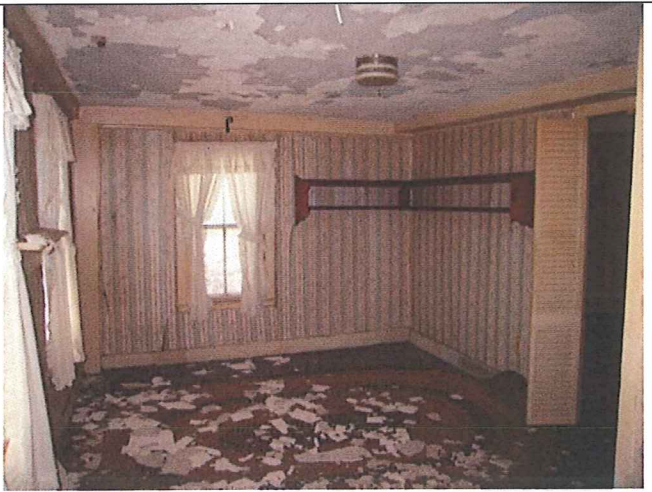
Here in the second floor south west room, is a revealed gunstock post whose casing has been removed to show that it increases from about 8" to 11" at its top flare, or "jowl". The wood is in pristine condition, and a small sample was taken to identify its species.

<p>The interior of the second floor south-west room. The tapered "gun-stock" molding in the corners reflects the tapered frame post behind. The taper accommodates a wider bearing area at the top for the multiple beam intersection</p>

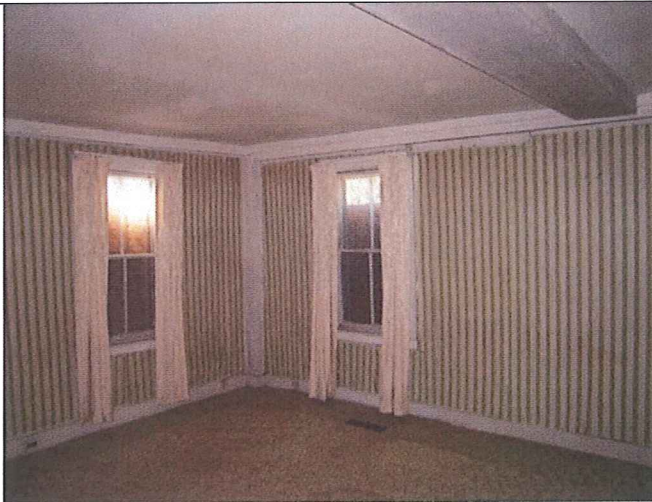
<p>Interior of a first floor room</p>

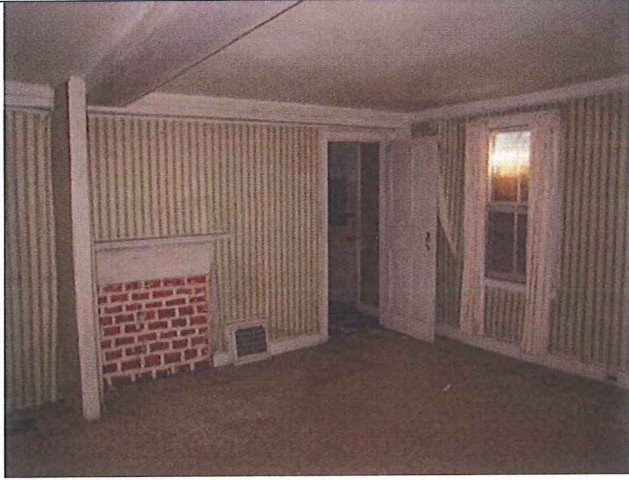
<p>Interior of the first floor south-west room. The fake brick panel shows where the original fireplace and chimney (along with the original stair) have been removed</p>

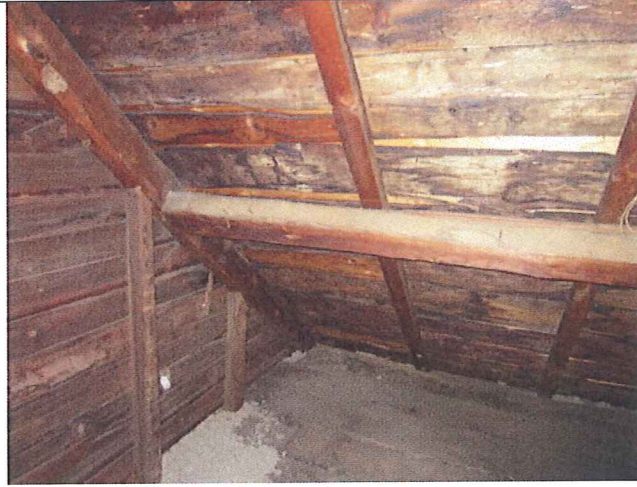
<p>Roof structure at the gable end wall</p>

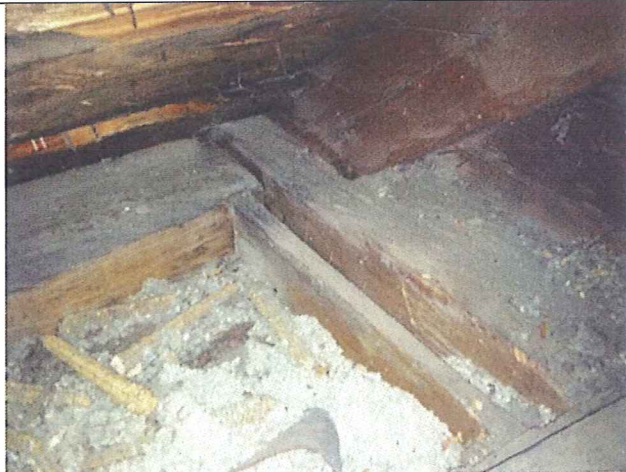
<p>Connection of the primary rafter to the perimeter plate/beam. The image shows the ceiling joists as well — along with what looks like corn-cob insulation.</p> <p>For the most part though, the insulation is recently installed dense packed cellulose</p>

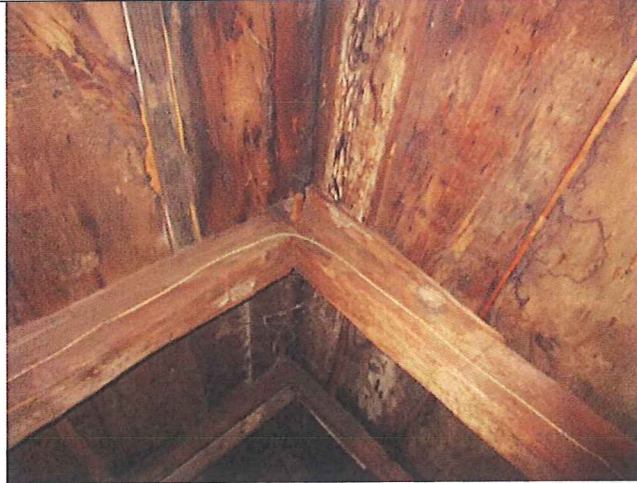
<p>Junction of the tertiary rafters at the ridge. They are pegged</p>

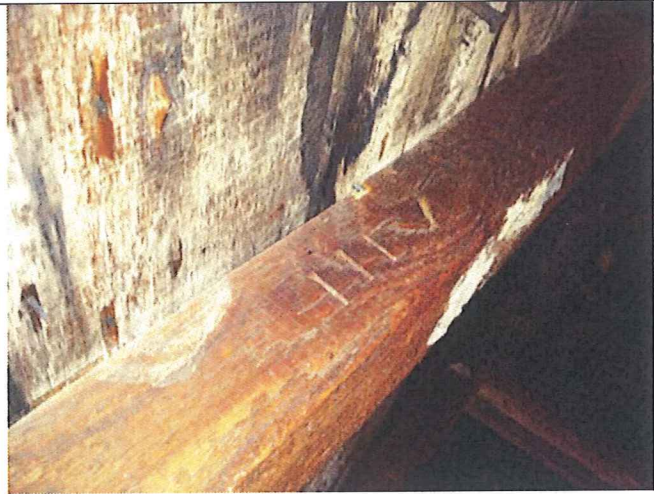
At the roof we also noted additional evidence of the framing of the house. The principal and common rafters of the roof are engraved with marriage marks as show in the two following photographs, so that after their joints at the roof ridge were individually cut into mortise and tenons, they could be laid aside and then re-assembled as the framers got to the roof structure.

<p>The primary evidence of the very early nature of this timber frame — each of the tertiary rafters are uniquely “scribed” indicating that each has been uniquely cut to match a complementary partner</p> <p>(For more information see Appendix C — the report by Bonnie Parsons on this historic framing technique)</p>

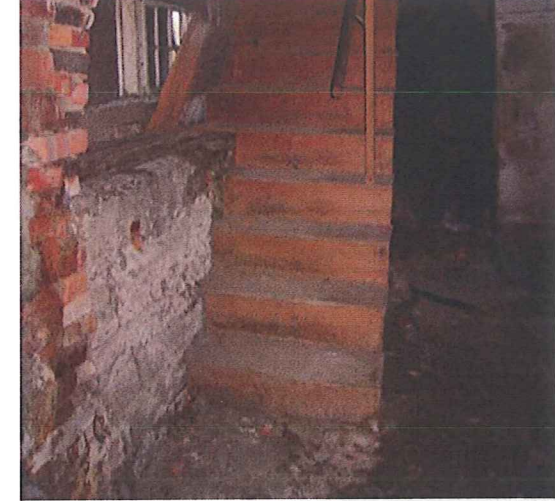
<p>The foundation under the house</p>

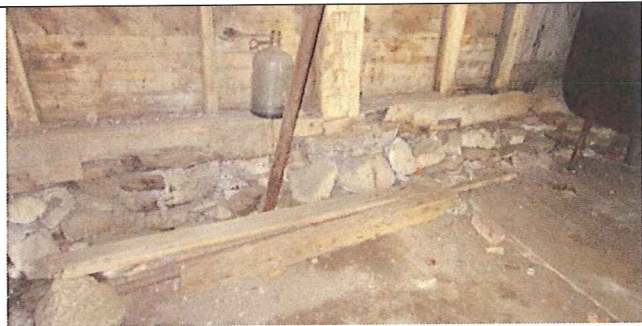
<p>The foundation structure below the "Ell".</p>

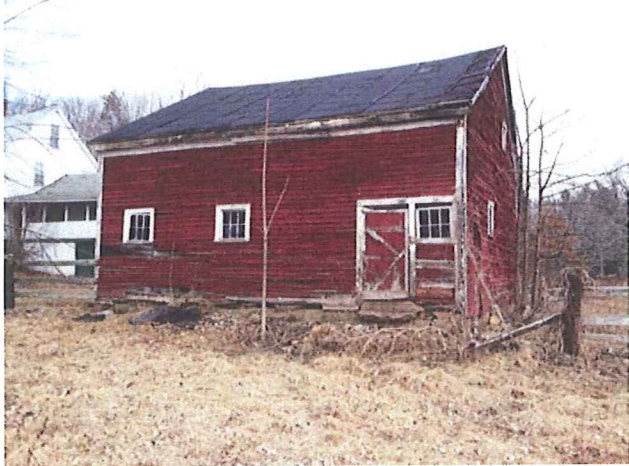
<p>The barn from the south</p>
